## Standard Guide for Visual Inspection of Electrical Protective Rubber Products<sup>1</sup>

This standard is issued under the fixed designation F 1236; the number immediately following the designation indicates the year of original adoption or, in the case of revision, the year of last revision. A number in parentheses indicates the year of last reapproval. A superscript epsilon (ε) indicates an editorial change since the last revision or reapproval.

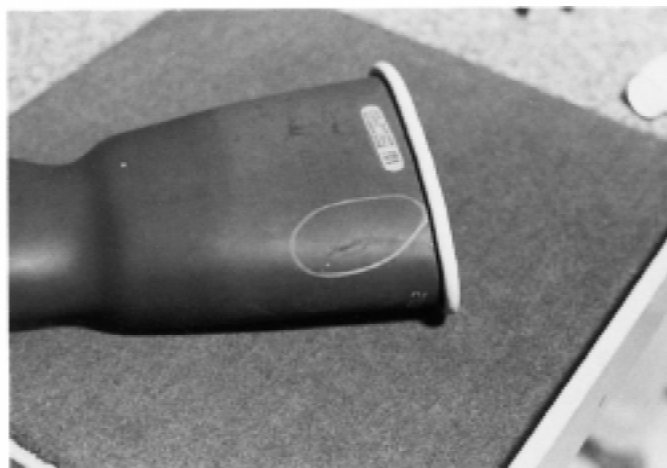
FIG. 1 Abrasion

3.1.1 *abrasions and scratches*—surface damage that normally occurs when a product makes contact with an abrasive surface. Scuff-like damage can also occur from a brush contact with a hot object such as a soldering iron. This can sometimes look like the graining on leather (see Fig. 1 and Fig. 2).
